## **Fort Leonard Wood Lake of the Ozarks Recreation Area, NRHP Section 110 Inventory and Evaluation**

Sunny E. Adams and Adam D. Smith

June 2016

Final report

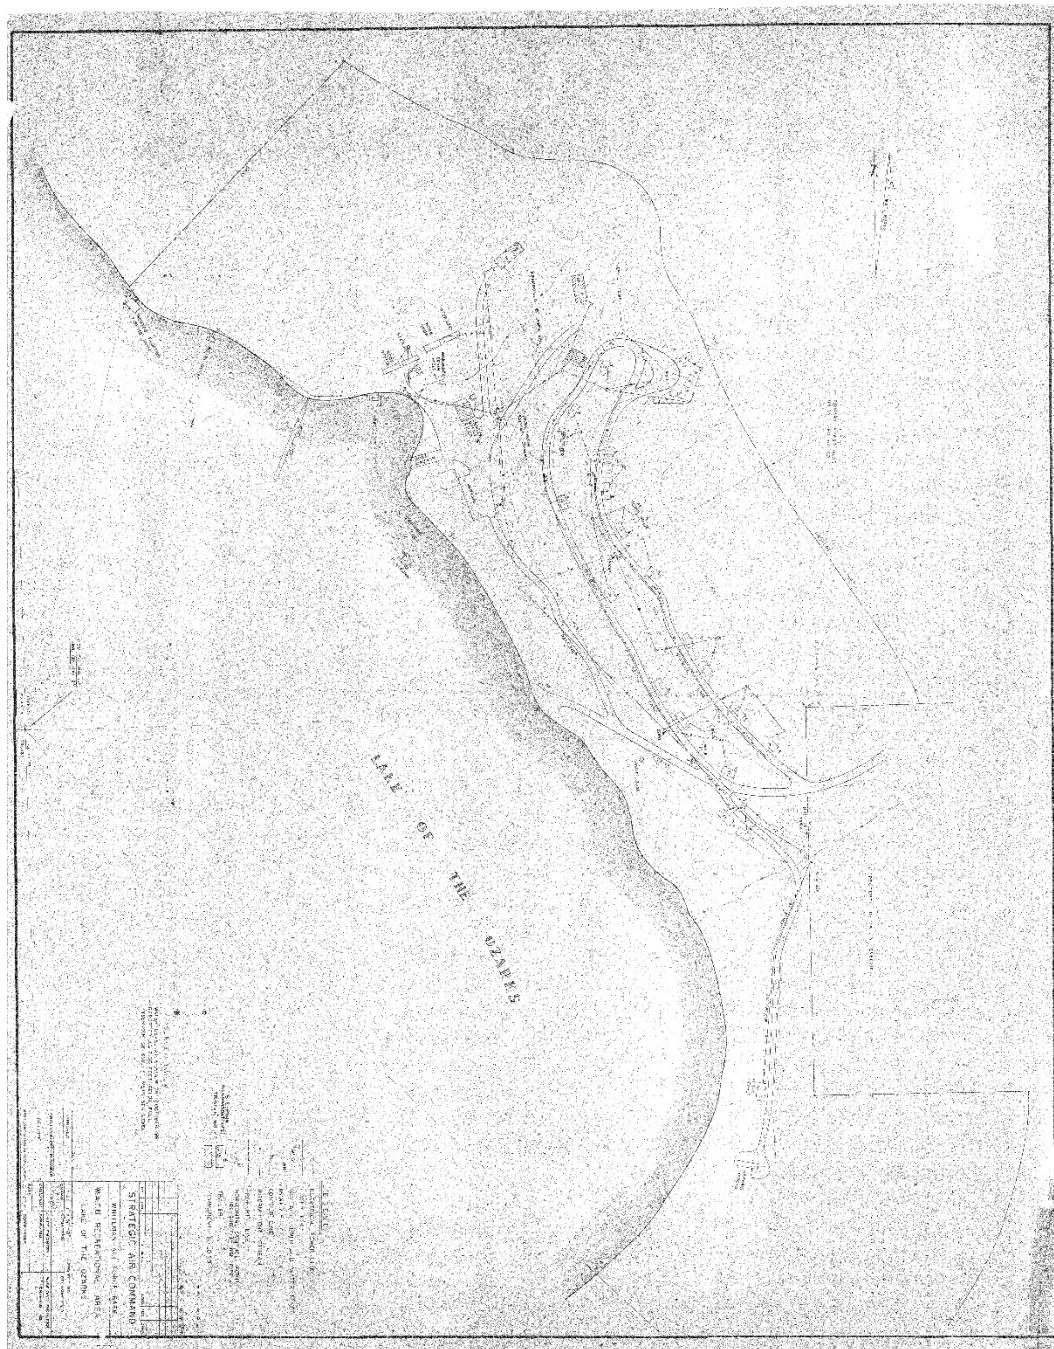
Figure 7. Site and utilities map for the southern recreation area (Whiteman Air Force Base), 1961 (DPW, FLW).

The south recreation area drawing from 1961 depicts roads, barracks, storage buildings, trailer office and sales building, a bath house, a boat launching ramp, a swimming area, boat docks, and 22 trailer/camp sites (Figure 7).

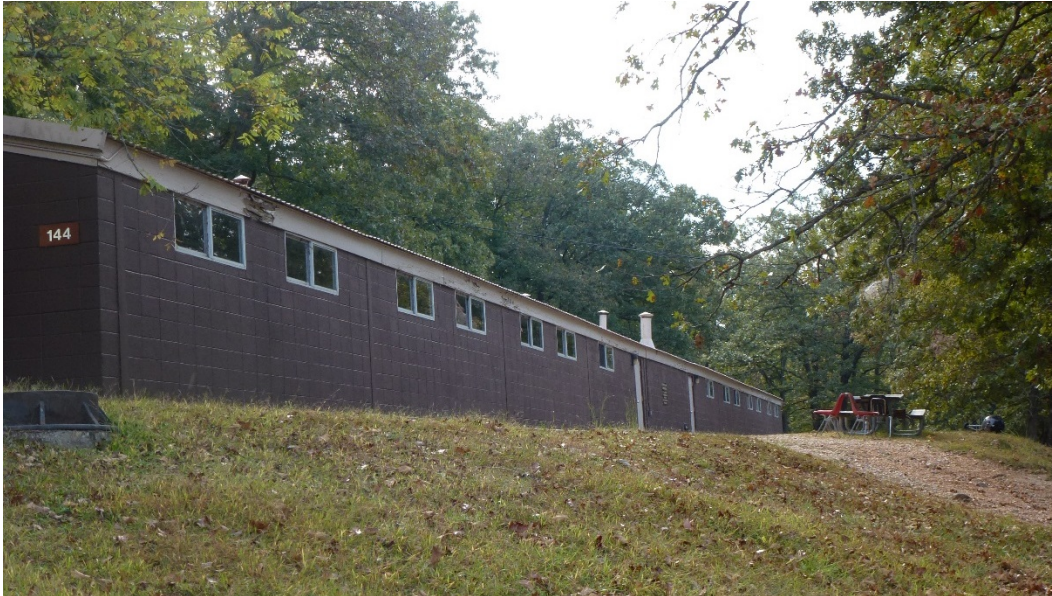
Figure 12. West elevation of Building 144 (ERDC-CERL, 2015).

Building 144 is a long one-story rectangular structure constructed of concrete block walls. The building has a side gable roof clad with metal roofing materials and wood fascia. The windows are metal-sash, single-pane slider windows that are located just below the wood fascia. The west elevation is symmetrical, with two single-entry doors located in the middle of the elevation and seven evenly spaced windows located on either side of the doors (Figure 12). The east elevation faces a concrete retaining wall. The elevation consists of fourteen windows (Figure 13). The north and south elevations each have a single entry door (Figure 14).

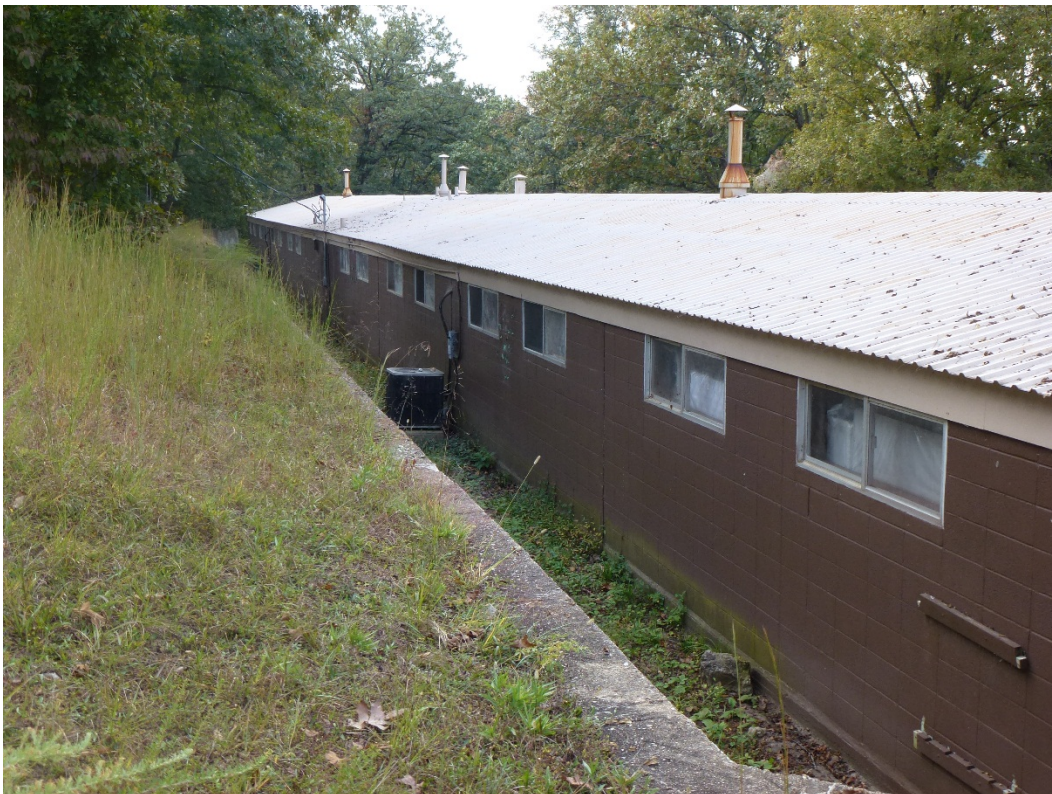
Figure 13. East elevation of Building 144 (ERDC-CERL, 2015).

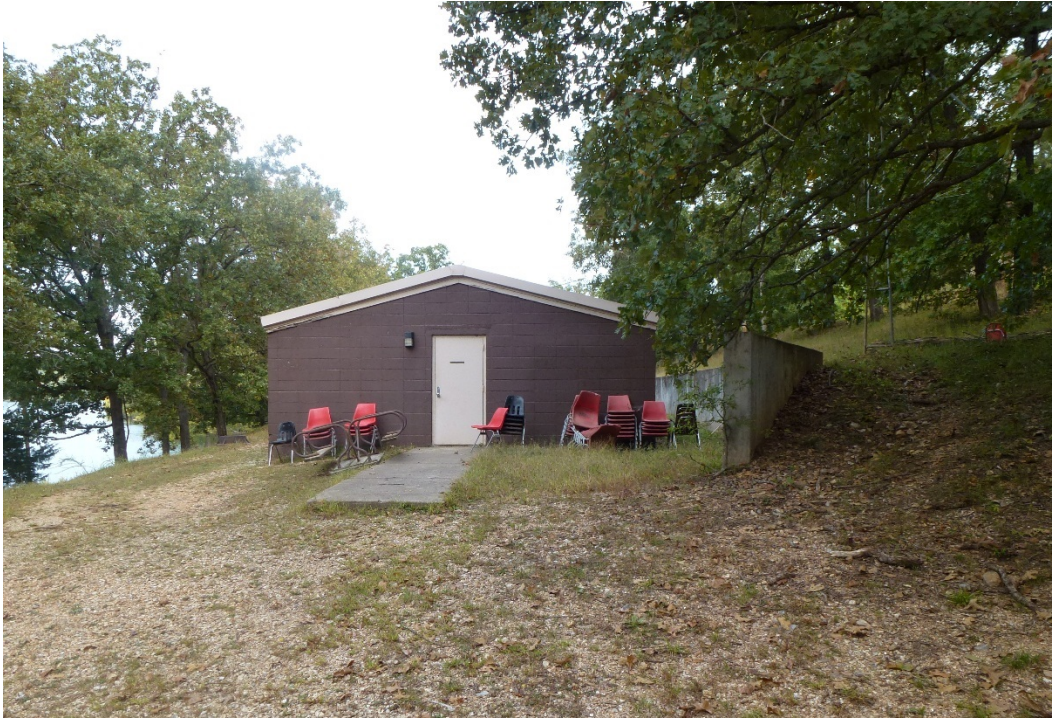
Figure 14. South elevation of Building 144 (ERDC-CERL, 2015).

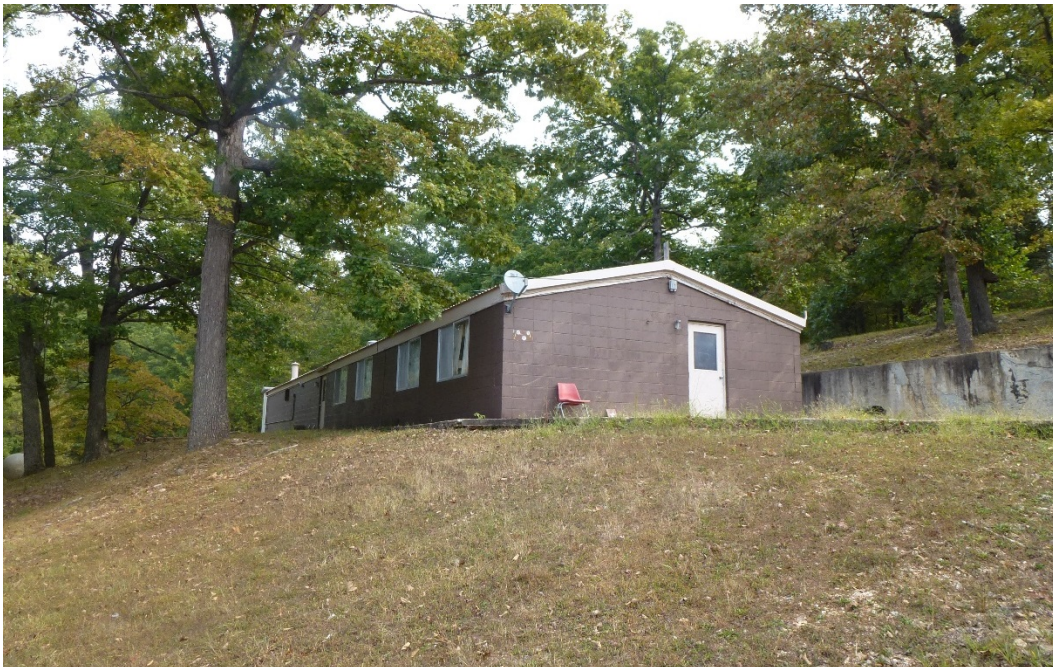
Figure 17. Southwest oblique of Building 146 (ERDC-CERL, 2015).

Building 146 is a simple one-story building with a rectangular footprint, concrete block exterior walls, a side gable roof clad with metal roofing materials, wood fascia, and metal-sash single-pane slider windows (Figure 20). The west elevation faces the lake and has a single-entry door with a large pane located on the left side of the elevation, and four evenly spaced windows located on the right side (Figure 18). The east elevation faces a concrete retaining wall and contains four smaller windows (Figure 19). The north and south elevations each have a single-entry door (Figure 17 and Figure 21).

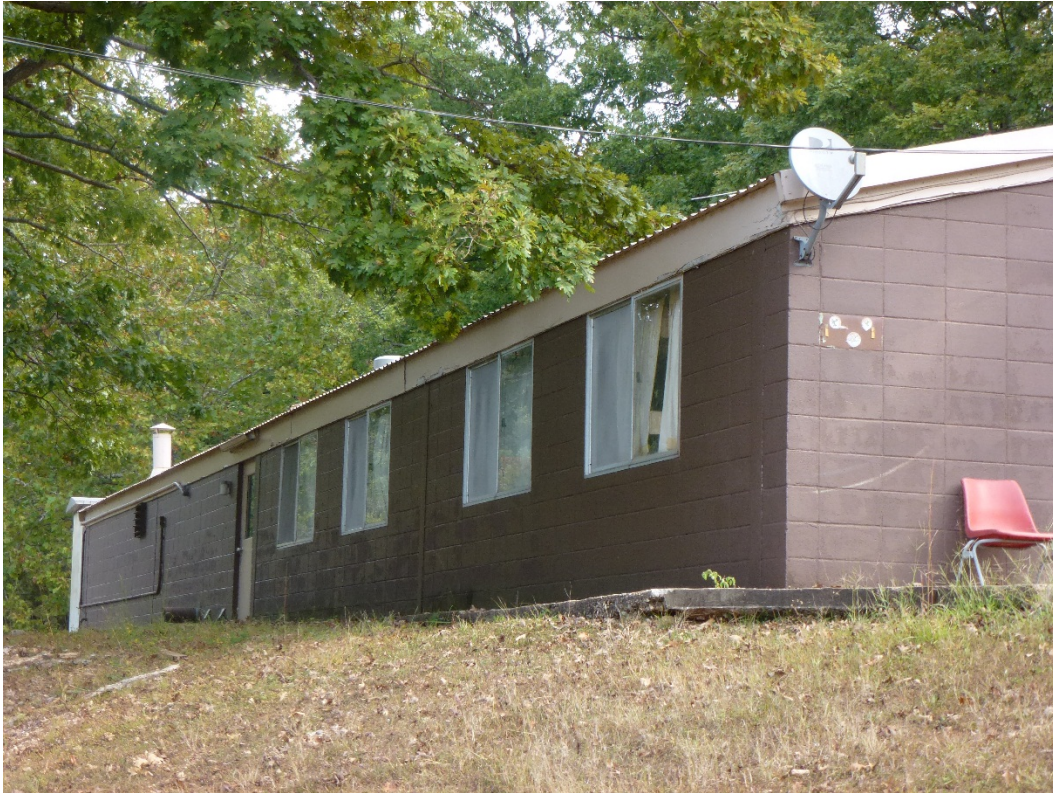
Figure 18. West elevation of Building 146 (ERDC-CERL, 2015).

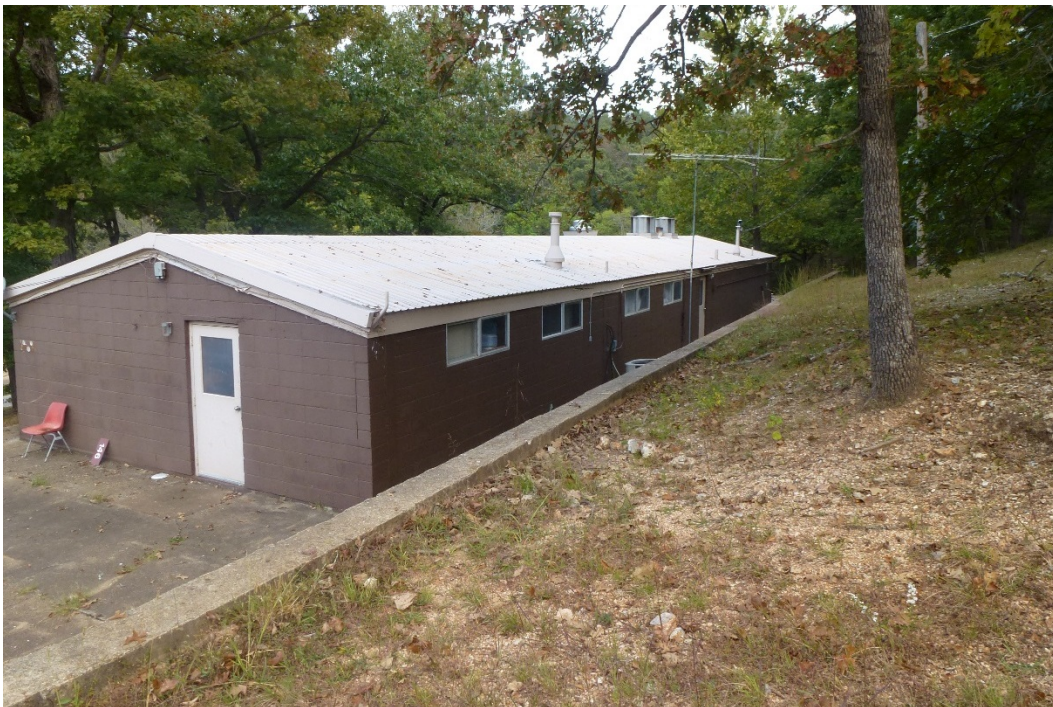
Figure 19. Southeast oblique of Building 146 (ERDC-CERL, 2015).

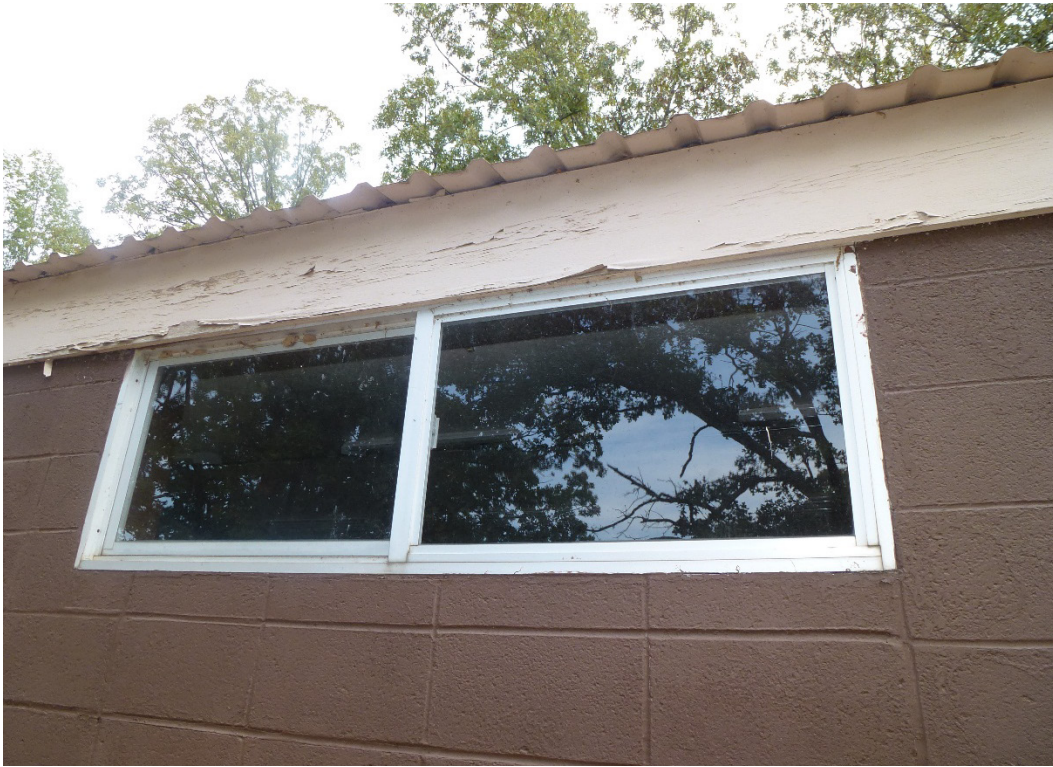
Figure 20. Close-up of metal-sash slider window, wood fascia, and metal roof decking on Building 146 (ERDC-CERL, 2015).

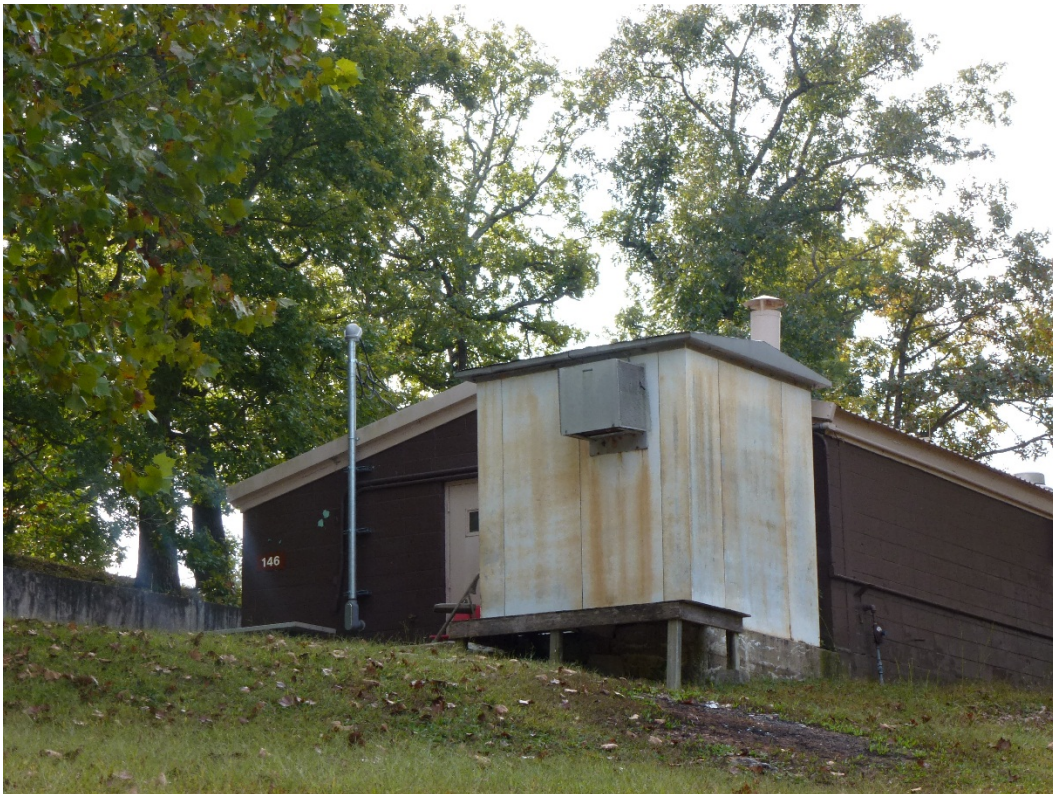
Figure 21. North elevation of Building 146 (ERDC-CERL, 2015).

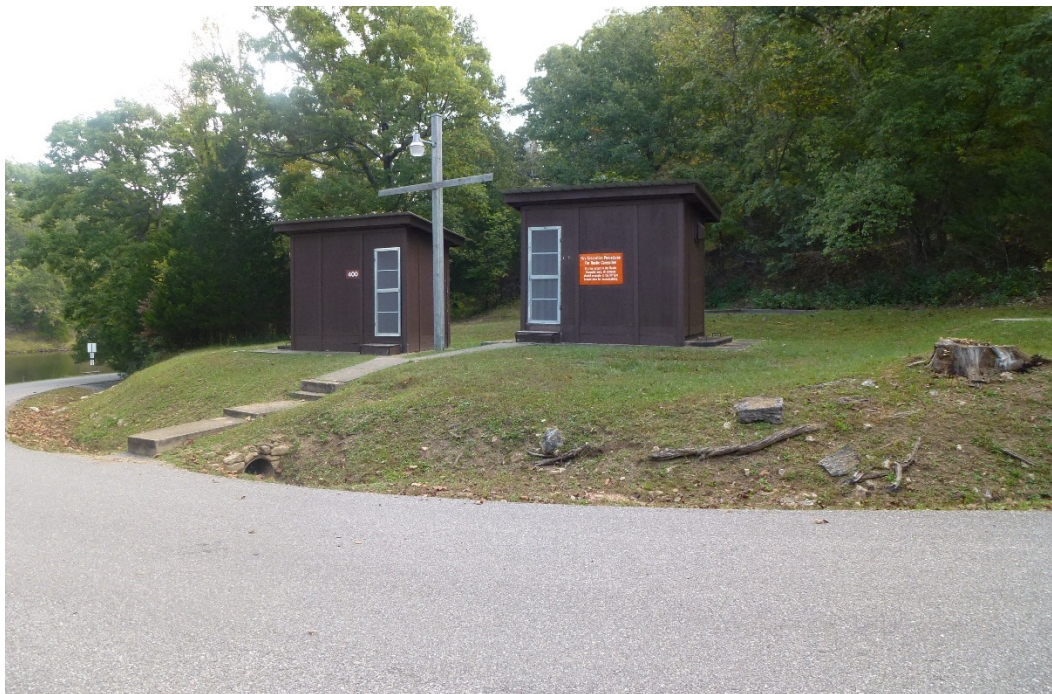
Figure 22. West elevations of Building 400 [left] and Building 401 [right] (ERDC-CERL, 2015).

Buildings 400 and 401, separate toilet/shower facilities, were constructed in 1969. The buildings are located on the southeastern side of LORA, off Lake Road. Buildings 144 and 146 are just west across Lake Road from these two structures. A poured concrete sidewalk leads from Lake Road to the facilities (Figure 22). A wooded area is located on the east side of the facilities.

Buildings 400 and 401 are small, simple structures. Each structure sits on a rectangular concrete pad. The walls are constructed of frame and filled with wood panels. The shed roofs are clad with newer metal roofing materials and overhang on all four sides, exposing the wood roof framing members. The west elevation of each structure has a single-entry metal screen door (Figure 23). The east elevations face a wooded area (Figure 24).

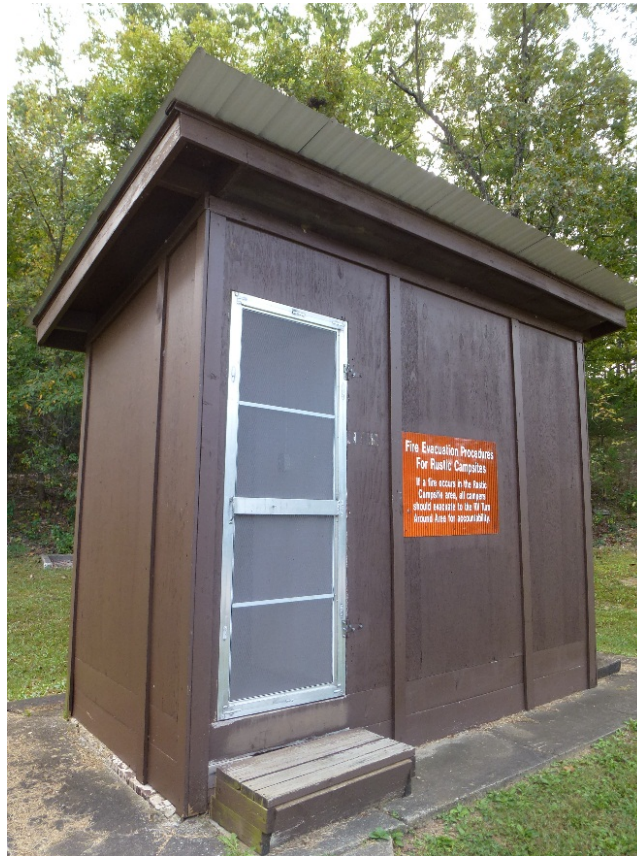
Figure 23. Northwest oblique of Building 401 (ERDC-CERL, 2015).

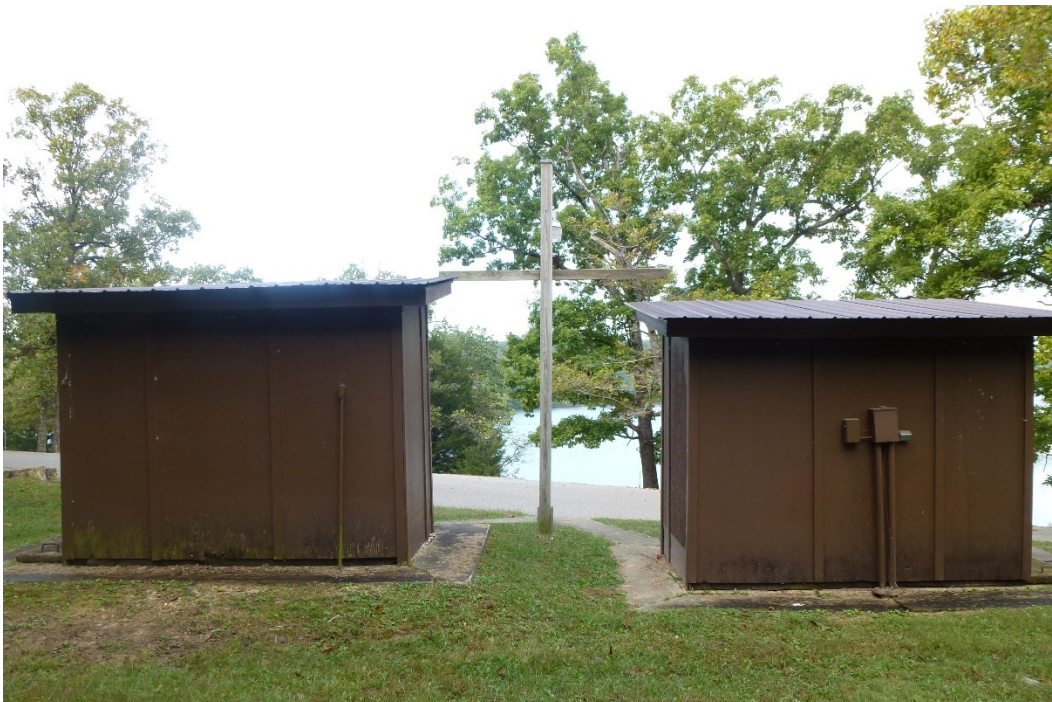
Figure 24. East elevation of Buildings 400 [right] and 401 [left] (ERDC-CERL, 2015).

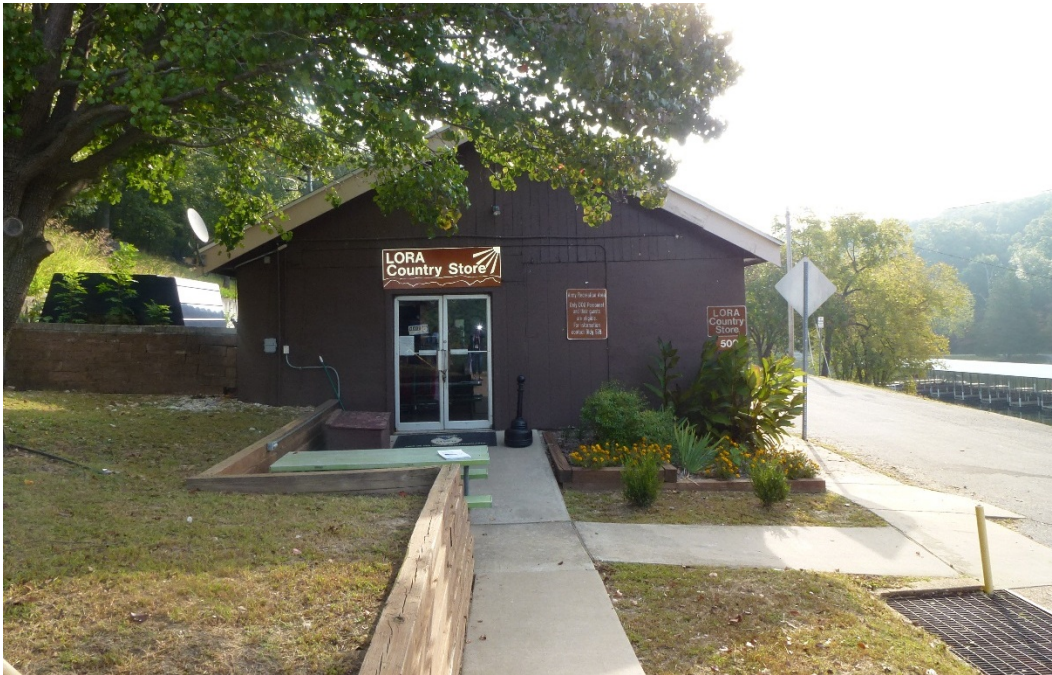
Figure 27. West (front) elevation of Building 500 (ERDC-CERL, 2015).

Building 500 is a simple, one-story rectangular building. The roof is a side gable that is clad with asphalt shingles, metal fascia, and has wood siding covering the gable ends. The exterior walls are clad with a stucco material. All of the window openings are currently covered with plywood. The main entry is located on the west side and is defined by a set of bright aluminum and plate glass doors (Figure 27). A wood-beam retaining wall frames a poured concrete sidewalk and pad leading to the entry doors. The south

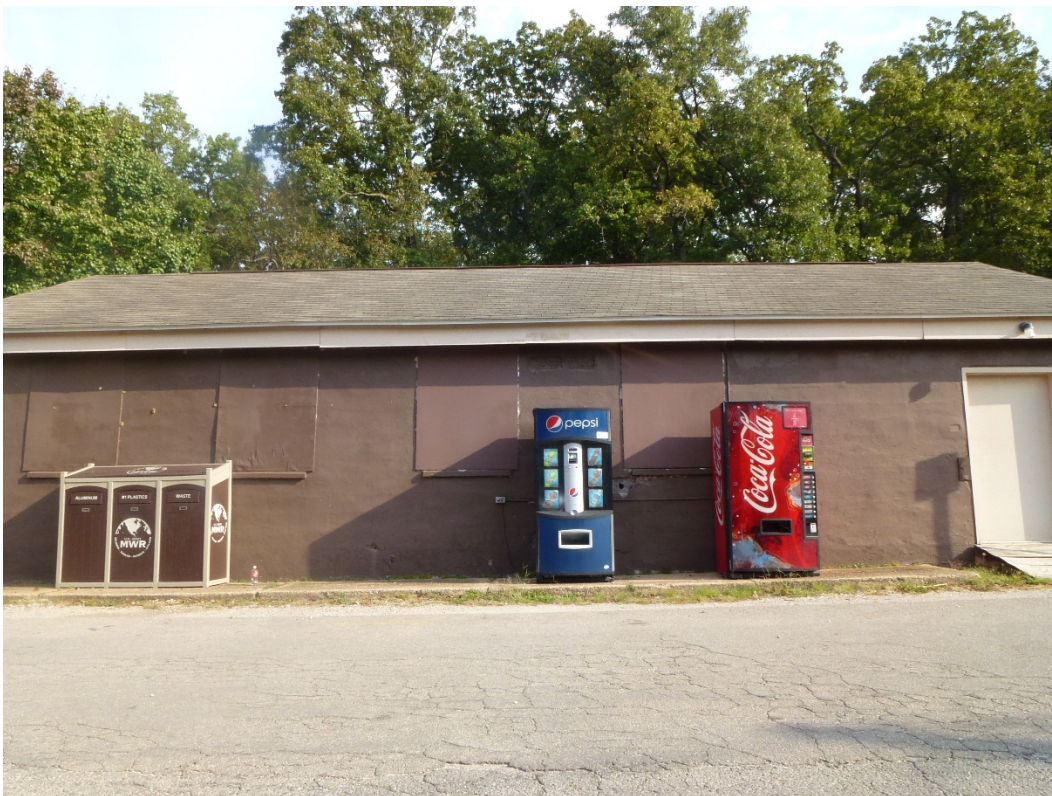
Figure 28. South elevation of Building 500 (ERDC-CERL, 2015).

elevation faces Olney Circle. There are four evenly spaced window openings and a single-entry door, which is located on the right side of the elevation (Figure 28). The east elevation faces a fenced-in area. There is a small lean-to addition located on the left side of the east elevation (Figure 29). There are three covered window openings on the north side of the building (Figure 30).

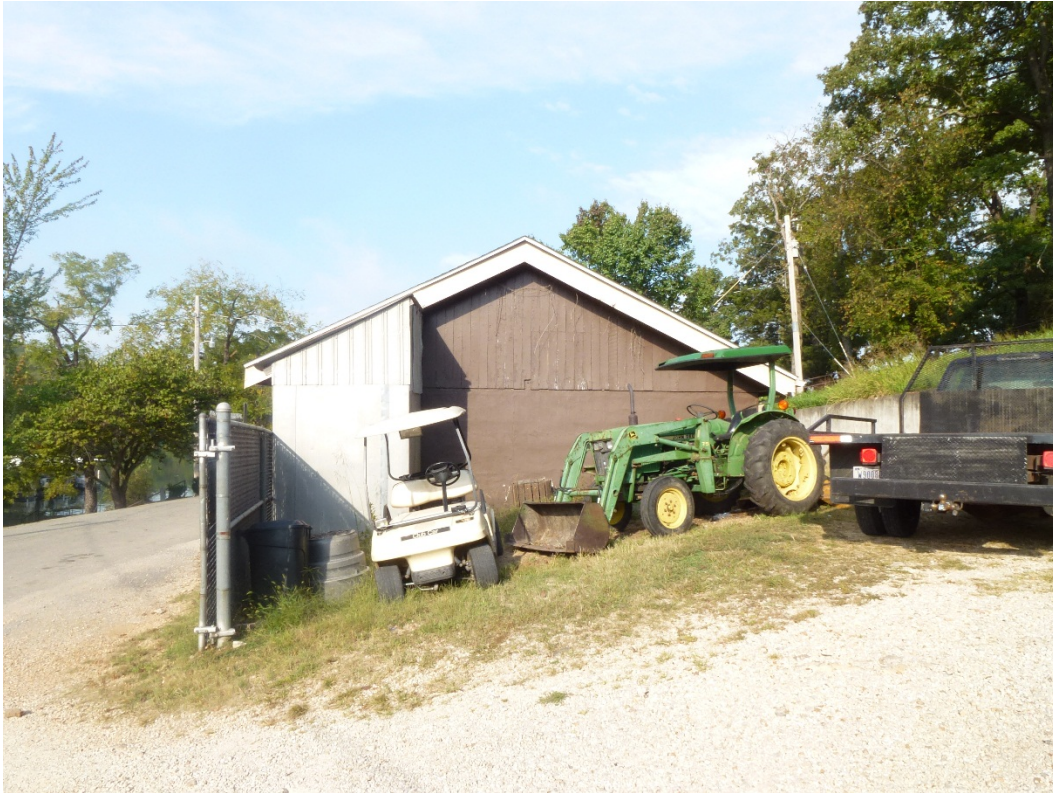
Figure 29. East elevation of Building 500 (ERDC-CERL, 2015).

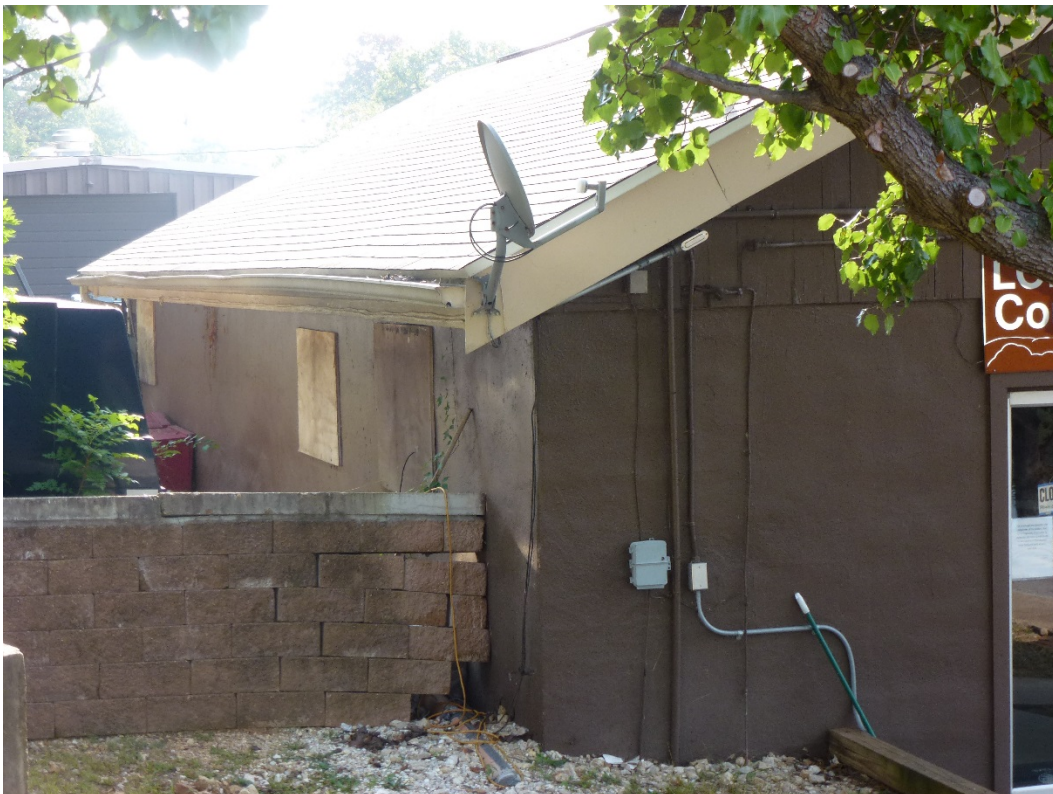
Figure 30. Northwest oblique of Building 500 (ERDC-CERL, 2015).

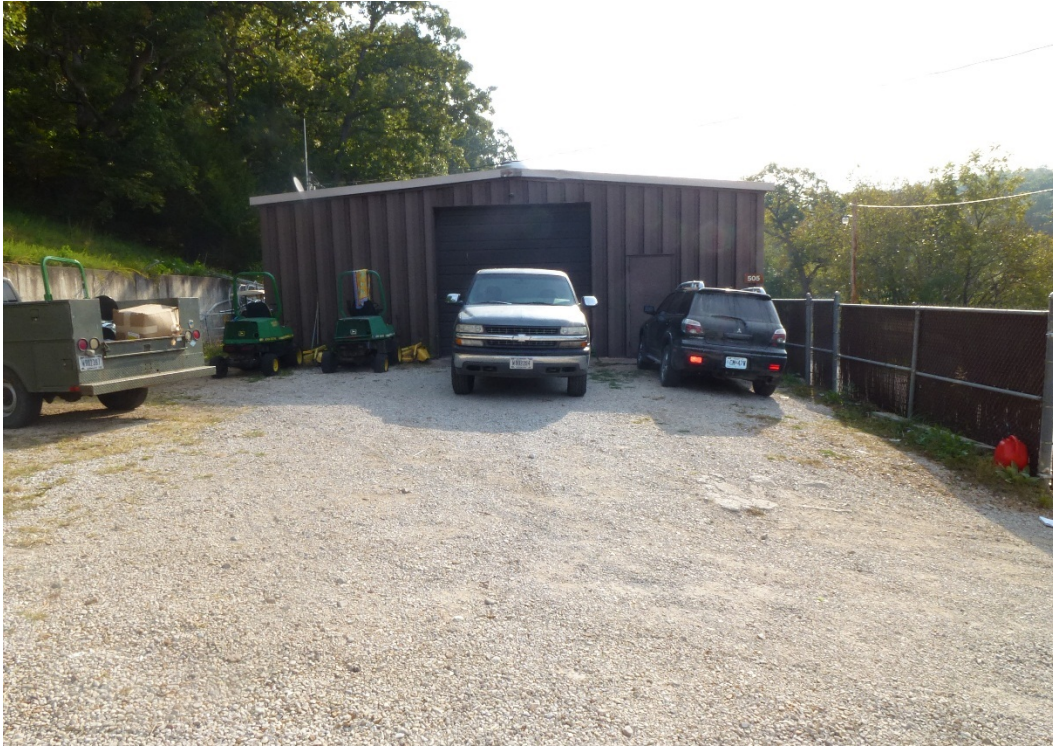
Figure 31. West elevation of Building 505 (ERDC-CERL, 2015).

Building 505 is a long, one-story rectangular structure with a raised concrete foundation, metal-clad exterior walls, and a gable roof clad with metal roofing materials. The west elevation faces a fenced-in gravel area. A large metal overhead door is located in the middle and a single entry door is placed on the right side of the west elevation (Figure 31). The south elevation faces Olney Circle (Figure 32). It appears that, at some point, the original building constructed in 1961 received an addition. The left side of the building is clad with one type of metal siding, while the right side has a different metal siding and a different metal roof (Figure 33). It is unclear which portion of the building was the original and which portion was the addition. There is a single metal-sash window and small louvered vent located on the left side of the south elevation. At the far right side of the south elevation is a small concrete block lean-to addition. This addition has a shed roof and a raised concrete foundation. The east elevation faces another fenced-in area. The concrete block lean-to is located on the left side of the east elevation, while a large metal overhead door is located in the center of the elevation (Figure 34). The north elevation faces a concrete retaining wall. There are no window or door openings on the north elevation (Figure 35).

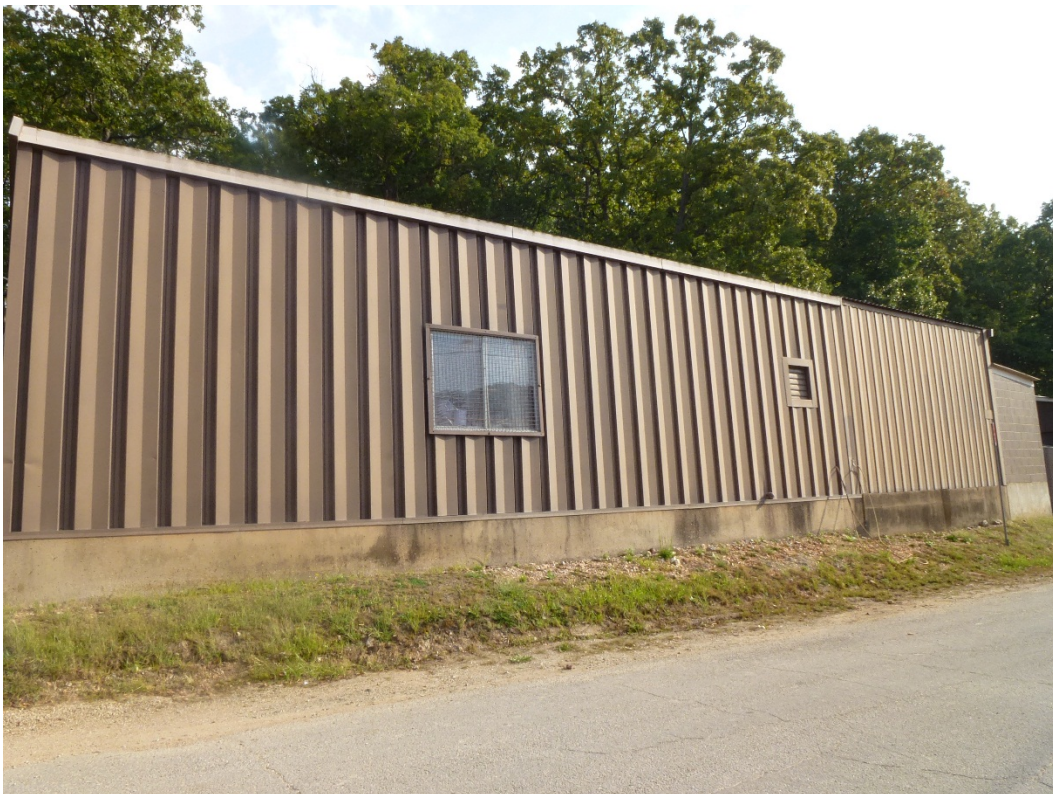
Figure 32. South elevation of Building 505 (ERDC-CERL, 2015).

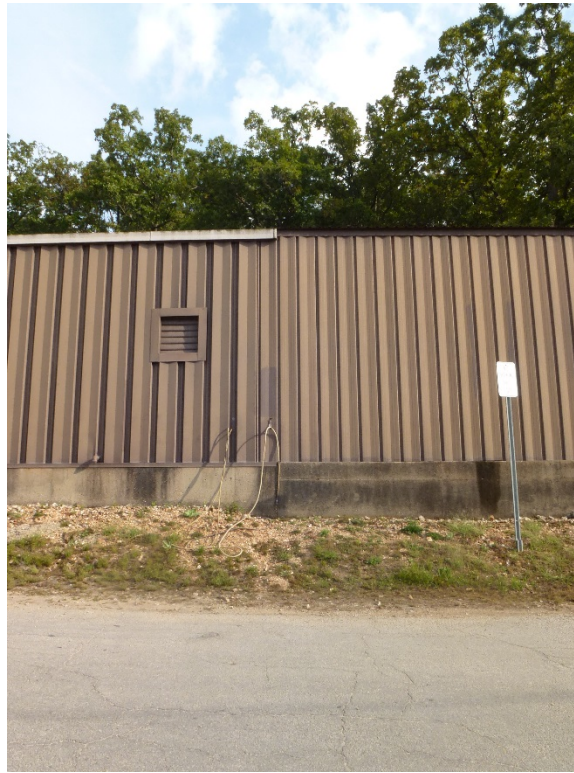
Figure 33. South elevation of Building 505, showing the connection between the original structure and the addition (ERDC-CERL, 2015).

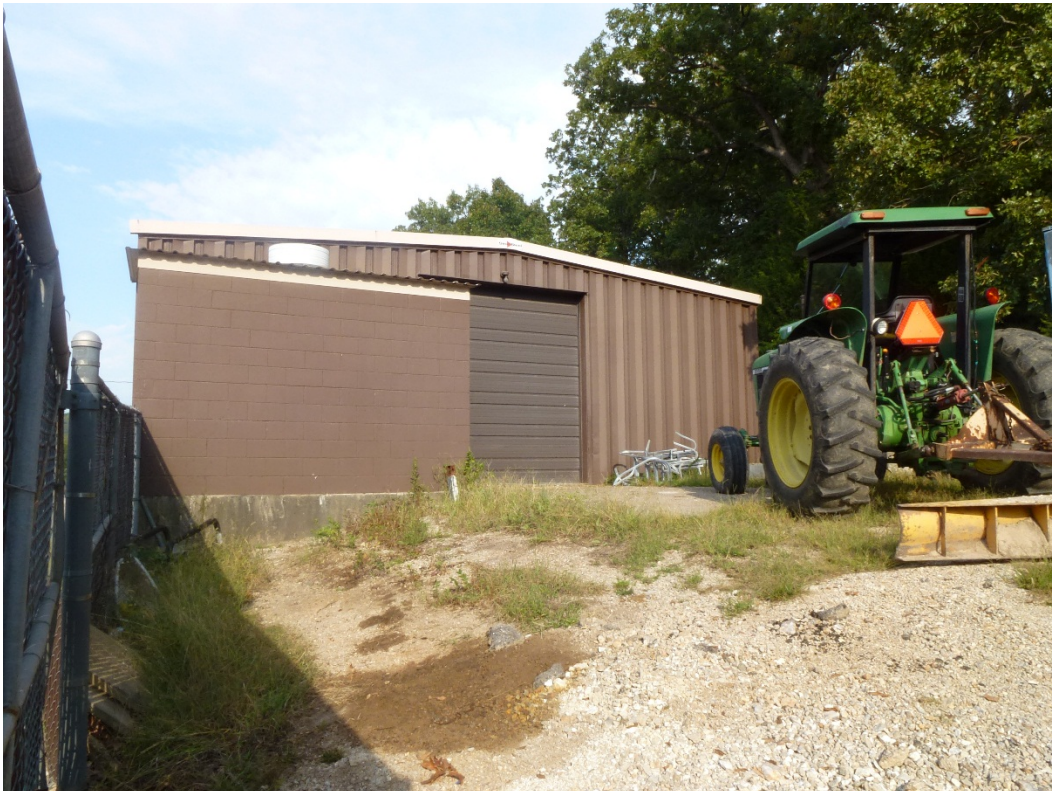
Figure 34. East elevation of Building 505 (ERDC-CERL, 2015).

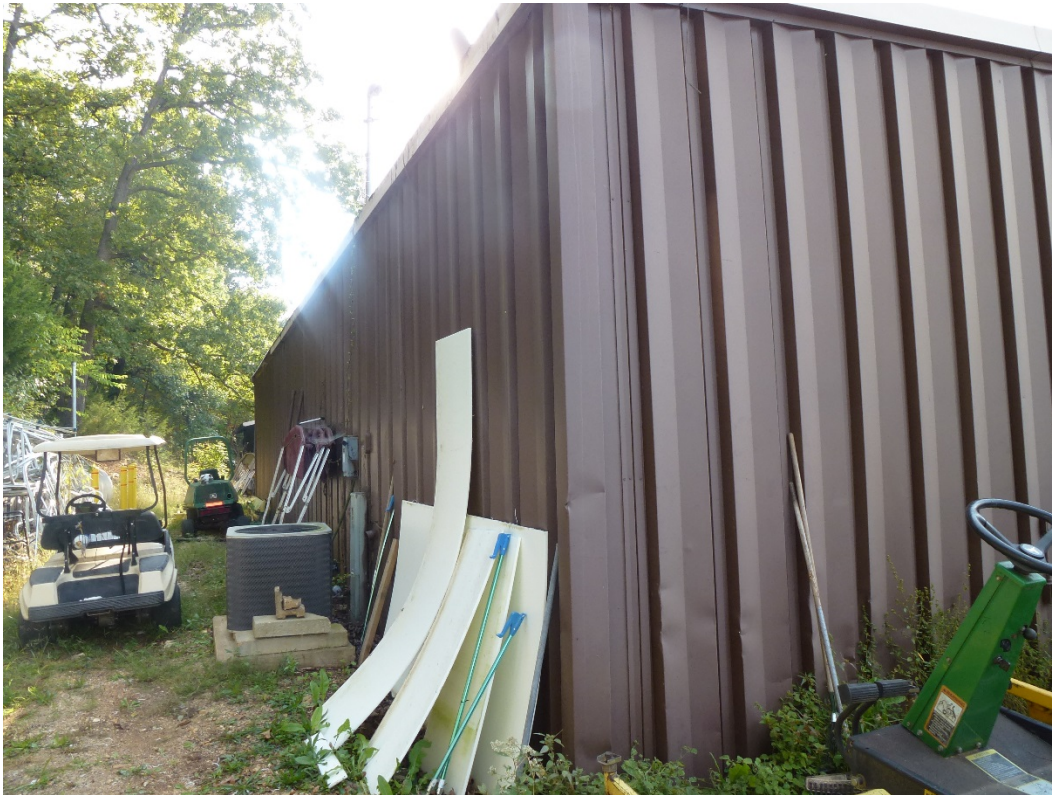
Figure 35. North elevation of Building 505 (ERDC-CERL, 2015).

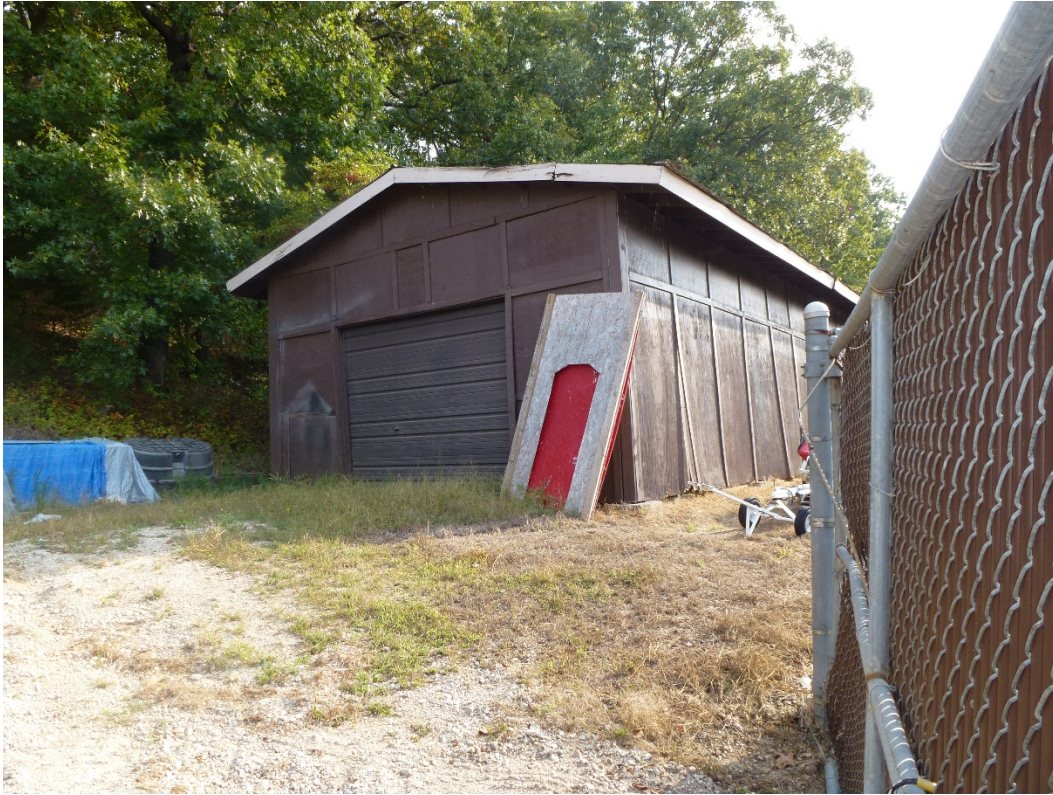
Figure 36. West elevation of Building 506 (ERDC-CERL, 2015).

Building 506 is a simple, rectangular, one-story wood-frame structure with a concrete pier foundation. The building's exterior walls are constructed of wood members, with plywood sheets as infill. The building has a side-gable roof with overhanging eaves, exposing the wood rafters on the north and south sides. The roof is clad with crimped metal sheets. The west elevation faces a fenced-in area. A metal overhead door is located in the middle of the elevation (Figure 36). There are no window or door openings on the north and south elevations (Figure 37 and Figure 39). The east elevation consists of a single-entry door (Figure 38).

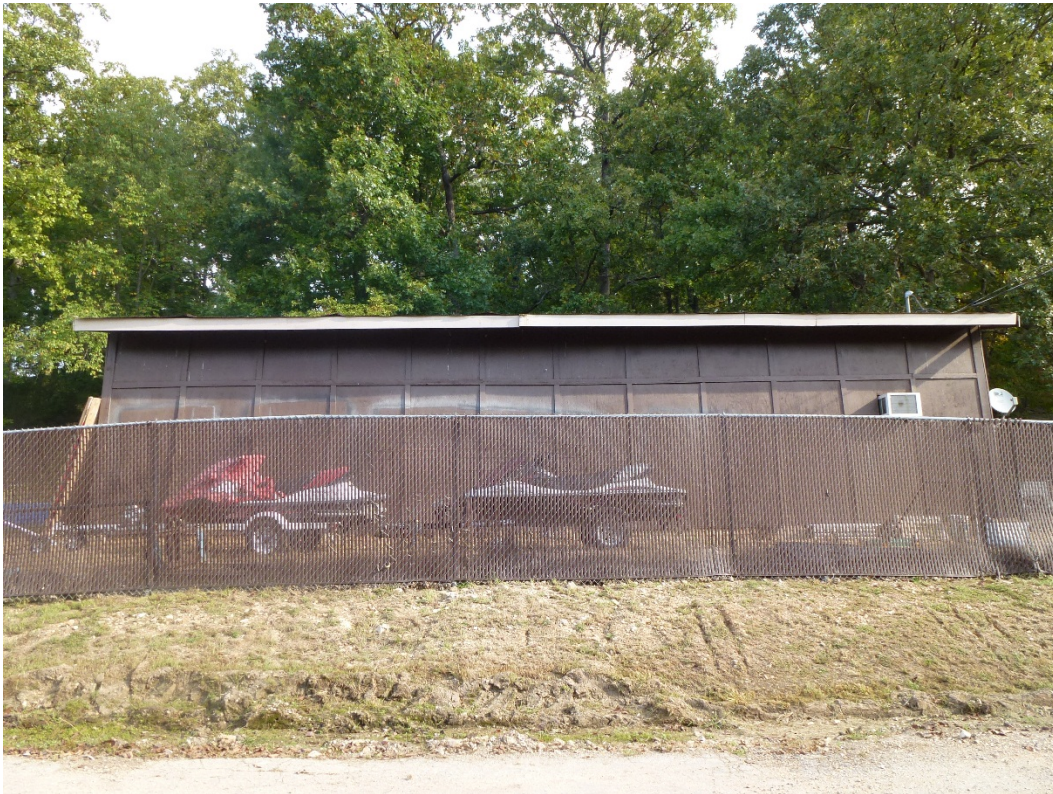
Figure 37. South elevation of Building 506 (ERDC-CERL, 2015).

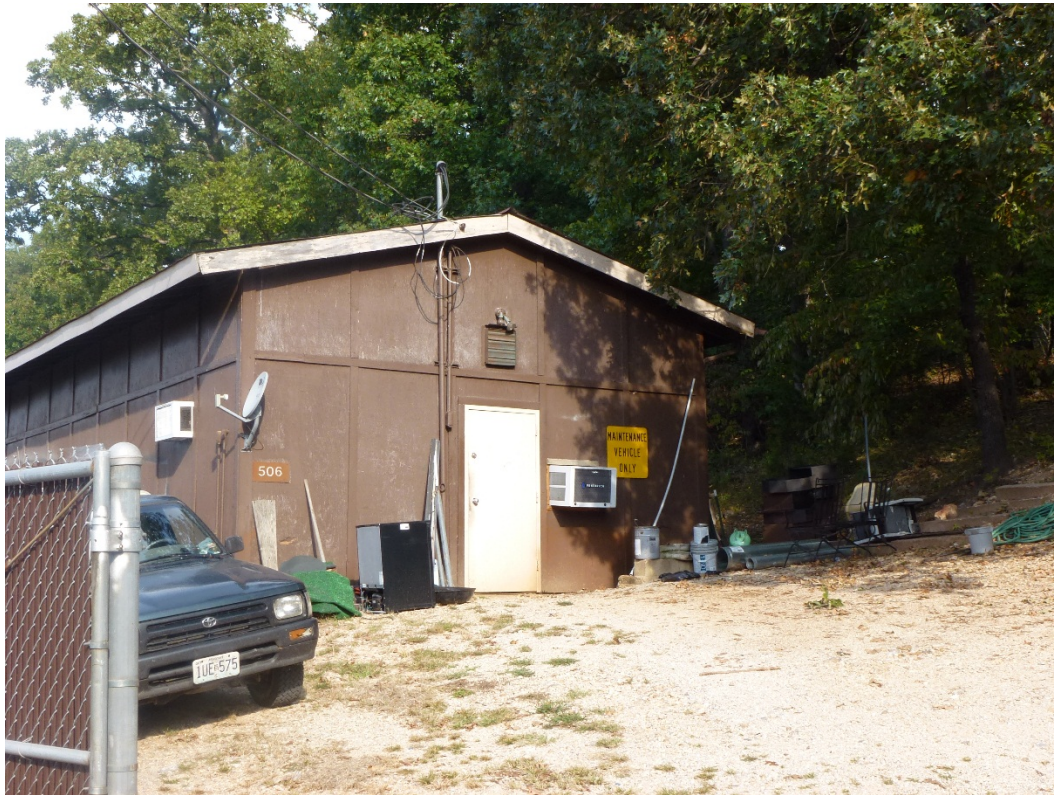
Figure 38. East elevation of Building 506 (ERDC-CERL, 2015).

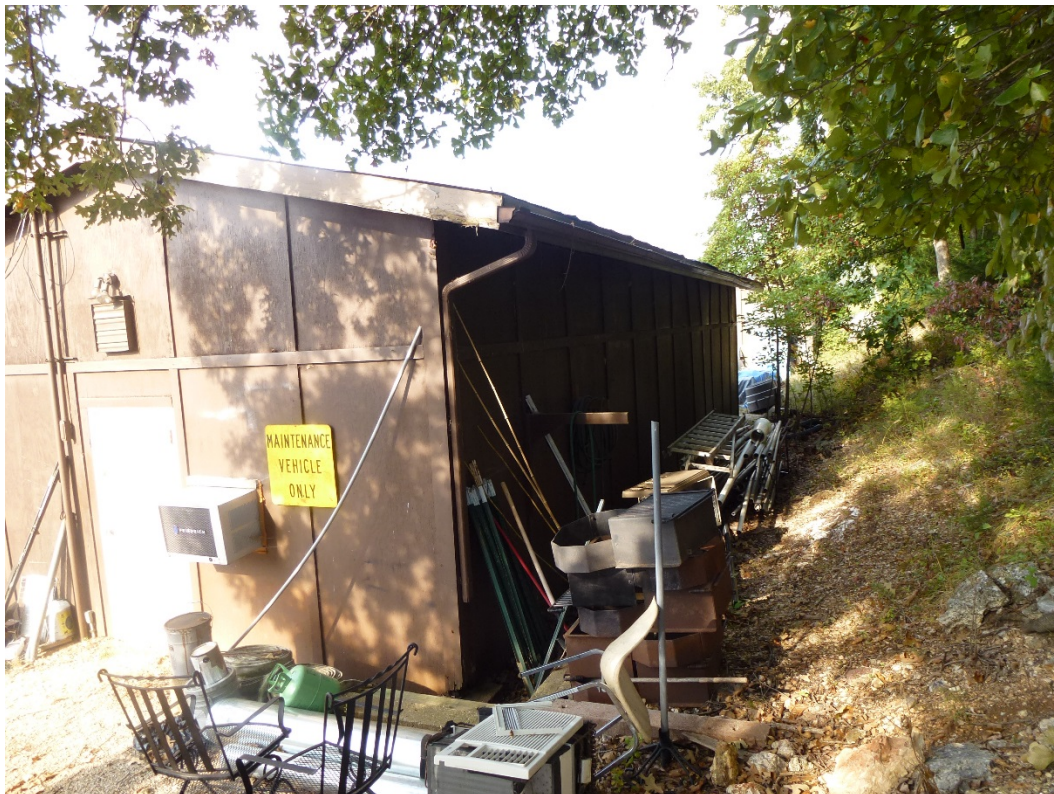
Figure 39. North elevation of Building 506 (ERDC-CERL, 2015).

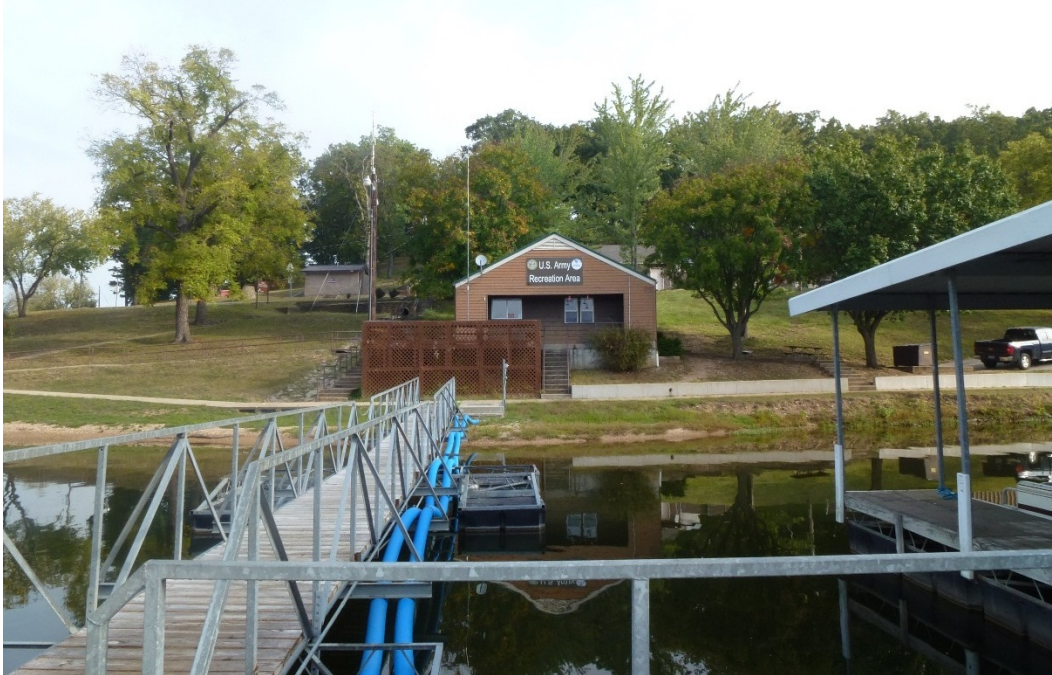
**Figure 41. Looking north from the marina toward Building 528 (ERDC-CERL, 2015).**

Building 528 is set within the slope of a hill. The raised concrete foundation is visible on the south side of the building (Figure 41). A poured concrete walkway encompasses the building on the east, south, and west sides. A set of poured concrete steps lead off the south elevation down to the marina. A wood-framed deck wraps around the building the left side of the south elevation and the west sides (Figure 42).
